Manhole Inspection Summary

Manhole # S43C2_021MH

Insp Date: **12/11/07 10:41 AM**

Location Address: **3751 Saint Margaret St**

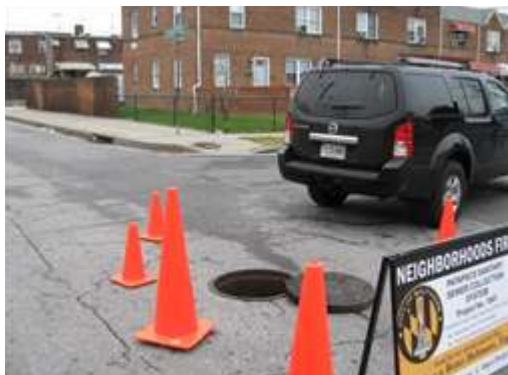
Location View

Washburn Ave.

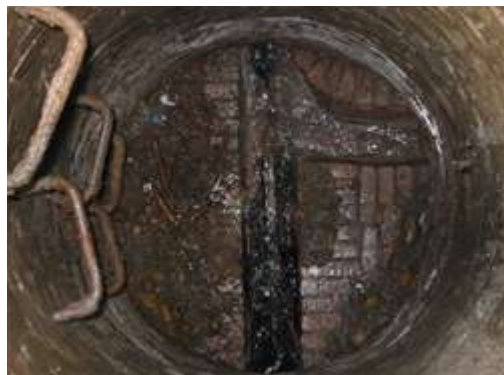
Top View

Steps

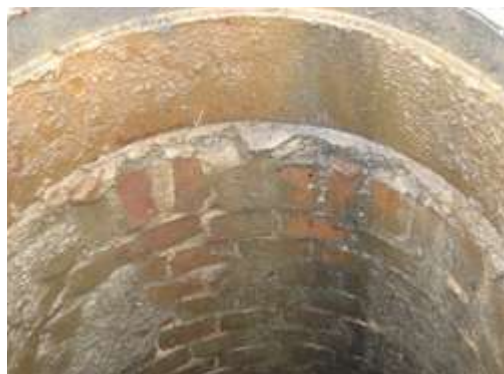
Defect 2

Infiltration: ☐ None ☐ Joint ☐ Cracks ☒ Mortar ☐ Roots ☐ Wall

Infiltration

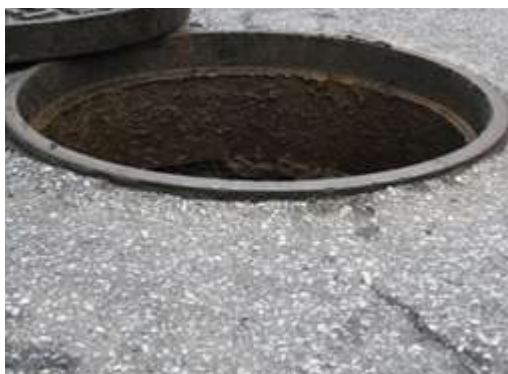
Defect 1

Diameter: **24** (in.) Length: (in.) Dist A/B Grade: **0.5** (in.)

Offset: **0.5** (in.)

Above grade

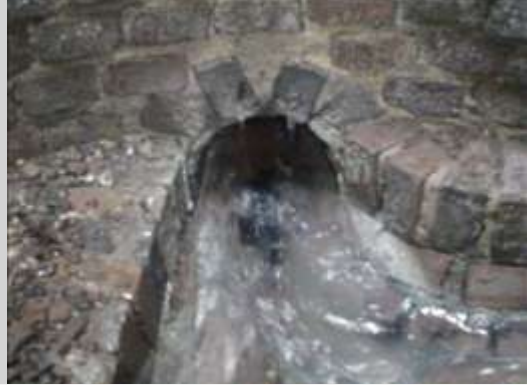
12 O'Clock Outflow

8 in. Circular Gravity Sewer
Pipe Out @ 12 O'Clock

Pipe Height: **9.6** (in.) Rod and Bar (Angled)
Pipe Material: **Clay** ☐ Pipe Lined
Invert Depth: **11.14** (ft.) Flow Characteristics: **Fast**
Deposits: ☒ None ☐ Mud ☐ Sludge ☐ Debris ☐ Grease
Silt Depth: (in.) Deposits Extent:
Infiltration: **None** Pipe Seal Cond: **Sound**

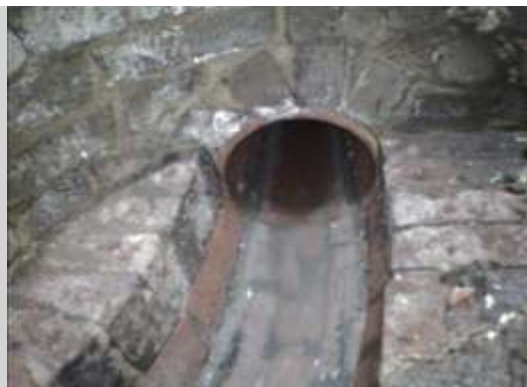
3 O'Clock Inflow

8 in. Circular Gravity Sewer
Pipe In @ 3 O'Clock

Pipe Height: **8.4** (in.) Rod and Bar (Angled)
Pipe Material: **Clay** ☐ Pipe Lined
Invert Depth: **10.92** (ft.) Flow Characteristics: **Fast**
Deposits: ☒ None ☐ Mud ☐ Sludge ☐ Debris ☐ Grease
Silt Depth: (in.) Deposits Extent:
Infiltration: **None** Pipe Seal Cond: **Sound**

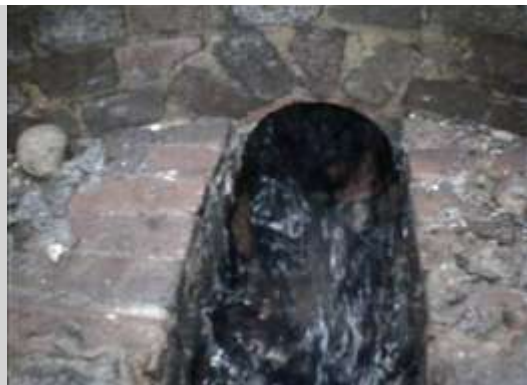
6 O'Clock Inflow

8 in. Circular Gravity Sewer
Pipe In @ 6 O'Clock

Infiltration: **None** Pipe Seal Cond: **Sound**
